## **IMPORTANT SAFETY NOTICE**

**1018534 1" 8.50t G-209 Shackle**

**1018543 1" 8.50t S-209 Shackle**

**With Production Identification Codes (PIC) TXJ as located on the shackle bow**

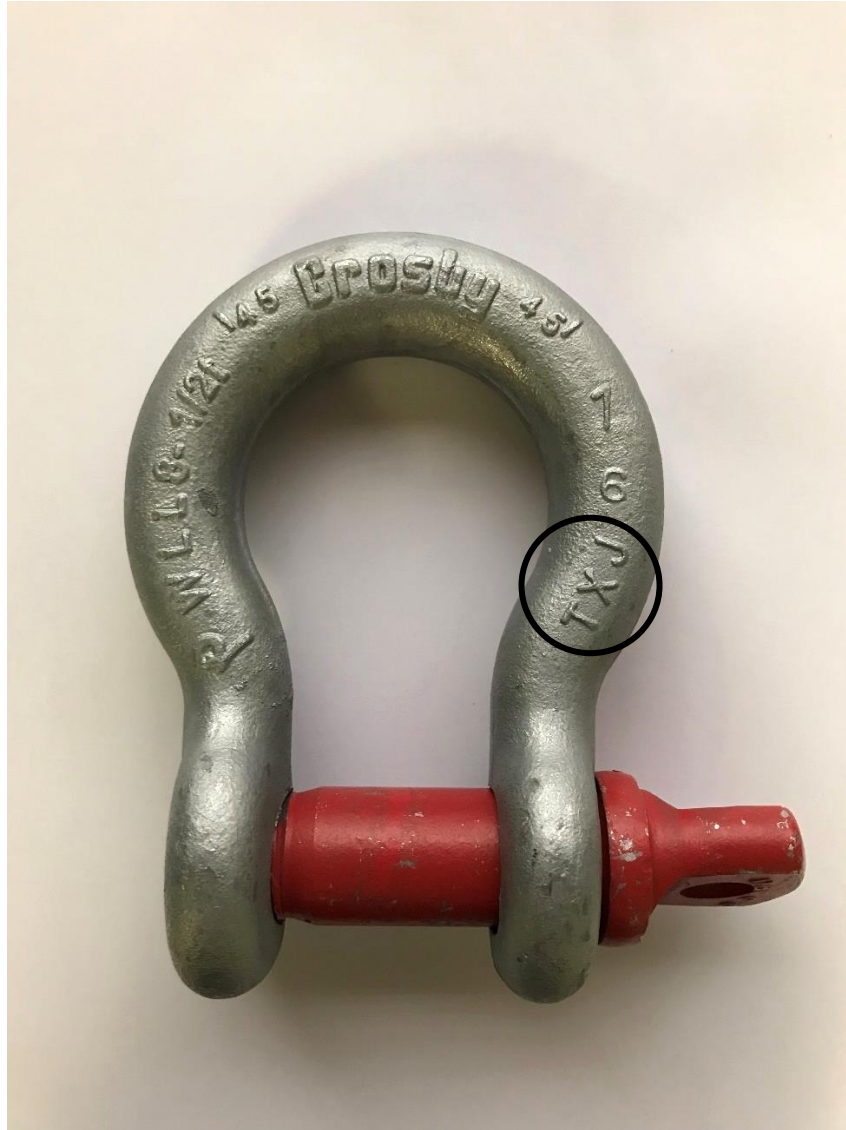
By use of the Production Identification Code (PIC) symbols appearing on the product, we have determined the 1" 8.5t screw pin anchor shackles with PIC TXJ shown on the bow may have this condition. See below image showing the position of the PIC on the bow. No other sizes or PICs are part of this Important Safety Notice. The potentially impacted products were shipped from Crosby between November 23, 2021, and January 28, 2022.

Production Information Code (PIC) Location

In the event you do have any 1" 8.5t shackles with PIC TXJ, we request you to remove them from service, and arrange for return and replacement. To return these products, please contact your Crosby Distributor. For more information concerning this Important Safety Notice, contact Technical Support at 1-800-220-8509 or [crosbytechsupport@thecrosbygroup.com](mailto:crosbytechsupport@thecrosbygroup.com).
